Longback Cottage

Level 1 Historic Survey

2021

Dobsons Design Ltd

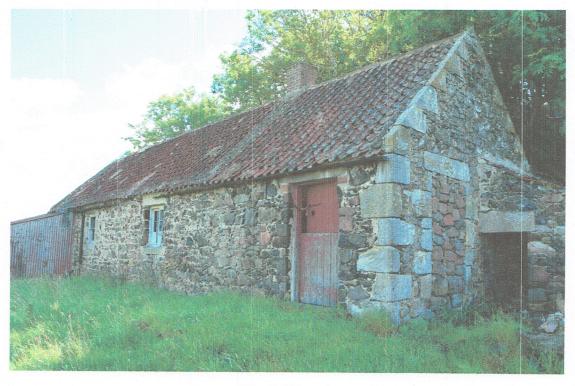
North Elevation

Traditional stable style door and 2 no. timber frame windows are located to the North. A built up doorway is clearly visible to the West, along with a dilapidated pigsty.

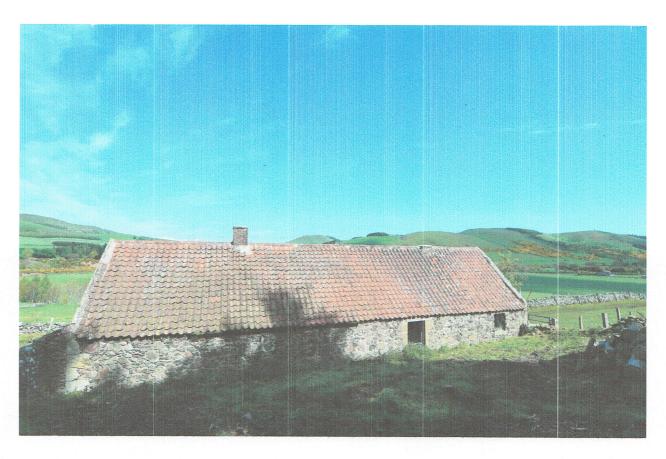
South Elevation

To the South are 2 no. timber framed windows and ground levels raise with this side of the Cottage dug into the hillside. Again, pantile roof to the South Elevation.

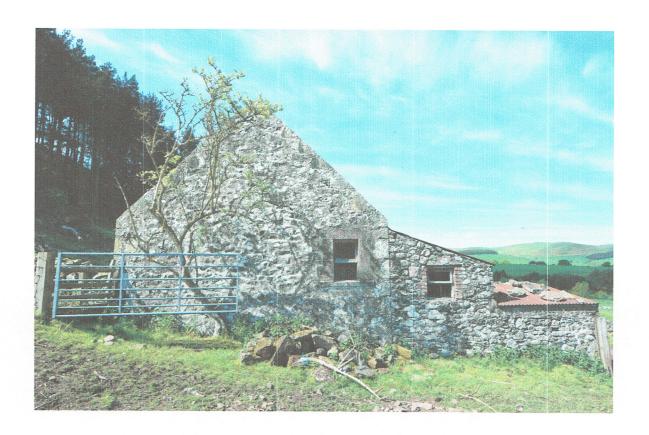
East Elevation

2 no. timber framed windows located to the East Elevation, along with the lean-to structure.

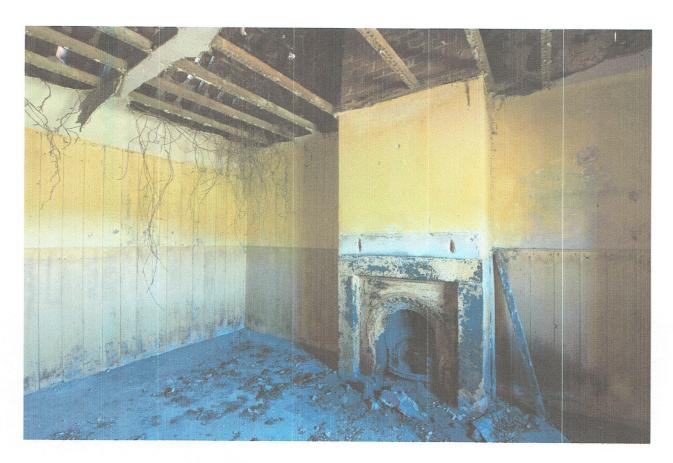
Photograph A (Bedroom)

Internally, as mentioned above and seen on the photographs below, Longback Cottage clearly has not been occupied since the 1950's and is in a dilapidated state. Vegetation is present, with plasterboard to ceilings crumbling and roof timbers clearly visible (see Photograph 'A').

In what would appear to be the bedroom, original fireplace still remains, along with traditional range in what would have been the kitchen come sitting room. Both rooms lit by windows (see Photographs 'A' & 'B').

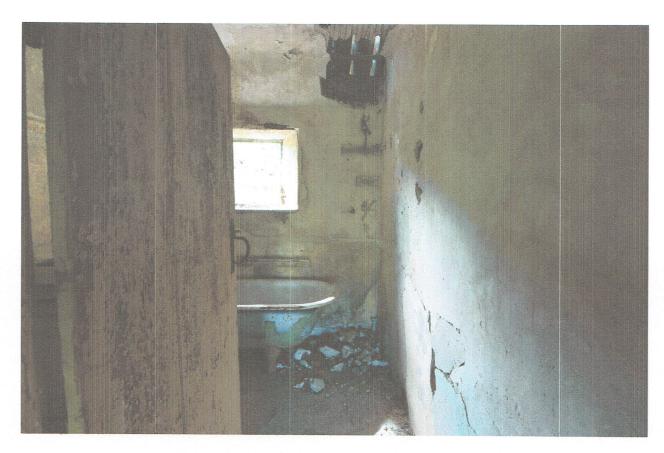
Photograph C (Bathroom)

Within the Bathroom, plasterboard to the ceiling is clearly crumbling away, along with walls. The room is illuminated by 1 no. window opening (see Photograph 'C').

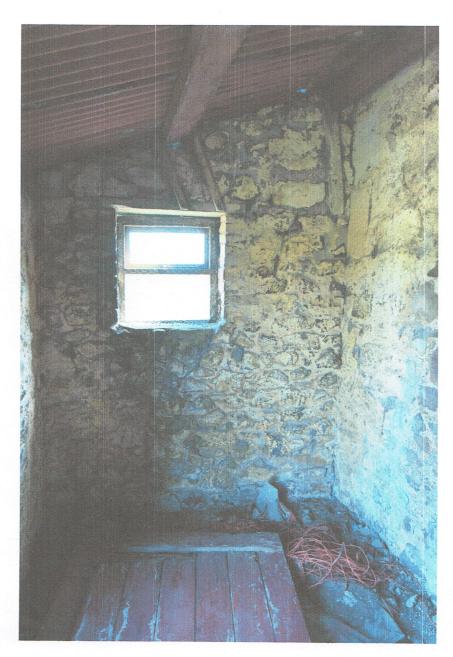
Photograph D (Lean-to)

Within the lean-to entrance, corrugated iron roof sheeting is exposed and internally illuminated by 1 no. window opening (see Photograph 'D').
