Item no.	Location	Defect description	Photograph	Recommended Repair & Quantity	Repair Category & Spec ref	Tender Cost
1.0.0	ROOFS					
1.1.0	Cart Shed

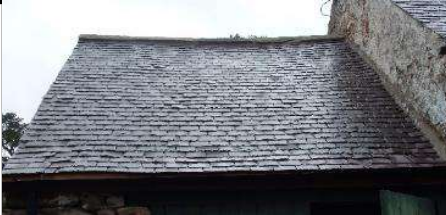
1.1.1	East Face	There are a few slipped and displaced slates. Rotten rafters, broken latts and corroded nails were noted.

Strip the slates and reslate the roof, rebedding the ridge and forming a mortar fillet at the roof abutment. (16.5m sq.)	2 Spec 1

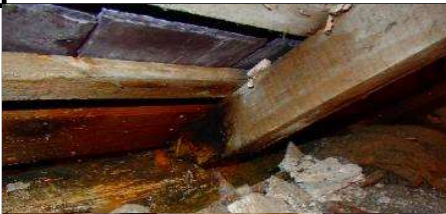
1.1.3	East side	The rafter feet are rotten and are not secure.

Cut out the rafter ends up to the first purlin and renew with new rafters from the purlin to the wallplate. (6no. 65x80mm rafters)	2 Spec 2

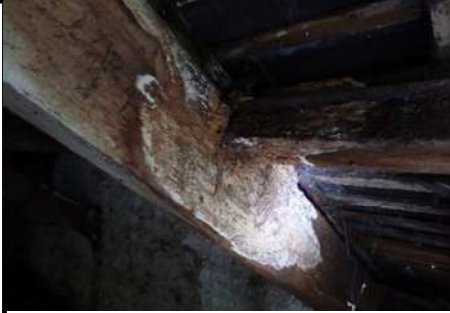
1.2.4	Trusses	The western rafter members of the trusses are rotten in places.

<p>Treat the timber for rot and allow for bolting new timber to the side of the principal rafter member of each truss.</p> <p>(2no. 225x75mm 4m long timbers bolted with M14 bolts at 300mm centres staggered along the centre line for the full length of the timber.)</p>	1 Spec 2

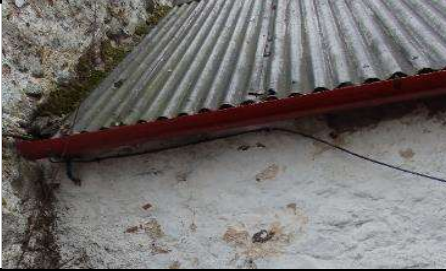
1.3.2	East roof	There is a build up of vegetation growth along the mortar filler with the abutment of the ganary building.

Clear off the vegetation and fully inspect the fillet. Renew the fillet if cracked/damaged. (2.8m)	1 Spec 1

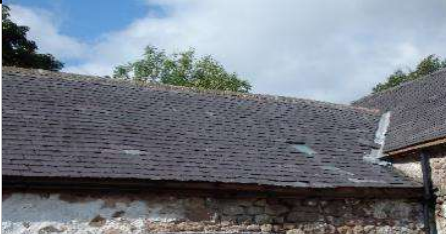
1.4.0	Rear Range					
1.4.1	South Roof	There are numerous slipped, missing, cracked and wired slates, despite recent repairs.

Strip the slates and reslate the roof, rebedding the ridge and form a new valley gutter. (60m sq.)	3 Spec 1

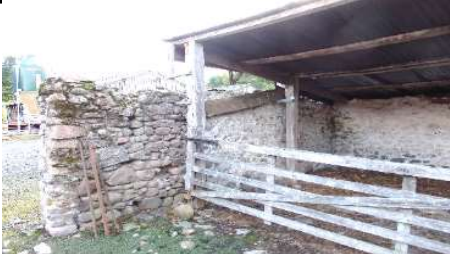
1.5.1		The existing purlins to the corrugated roof are overstressed and are deflecting.

Remove the sheeting and renew the purlins. (Allow 10no. 125x75mm timber purlins)	3 Spec 2	
1.5.2		A section of the lean to roof has collapsed and is missing.

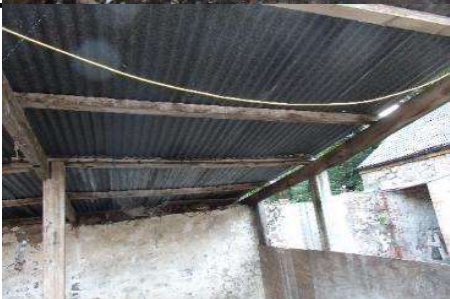
Item omitted		-
1.5.3		There is some corrosion to the existing metal sheet.

This is acceptable and does not require replacement at this stage.	-

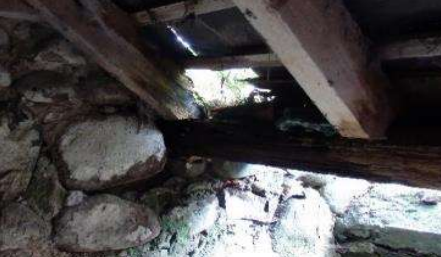
1.6.0		Pig Sty				
1.6.1	North roof	There are a number of missing, slipped and broken slates, and there is a gable at the junction with the bridge abutment.	 	Strip the slates and reslate the roof, rebedding the ridge and forming a mortar fillet at the junction with the bridge abutment (6m sq.)	1 Spec 1	
				(Allow a provisional sum for additional roofing slates)		
1.6.2	North roof structure	There is rot to the timber wall plate with loose stone below.	 	Chop out the rotten section of wall plate between the rafter members.	1 Spec 2	
1.6.3	South roof	There are a number of missing, slipped and broken slates.	 	Strip the slates and reslate the roof, rebedding the ridge. (6m sq.)	1 Spec 1	
1.6.4	South roof structure	The timber wallplate/lintel is rotten.

Renew the timber lintel. (Allow a 280x100 lintel/wallplate)	1 Spec 2

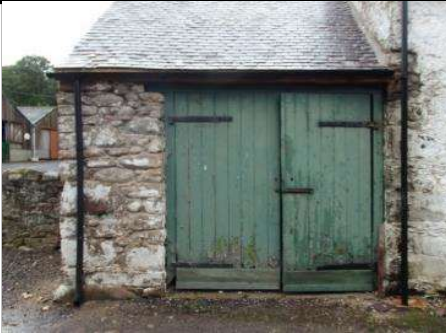
2.0.0 Rainwater Good						
2.1.0		Cart shed				
2.1.1	East & West faces	There is plastic guttering which has been mounted on timber facisa boards.

Remove the timber boarding. Renew with cast guttering and downpipes, and realigning the downpipe to discharge into a hopper and downpipe to the drainage gulley on the east. (2no. lengths of 3.5m of guttering with 4no. stop ends, 2 outlets, spiked gutter brackets 2no. 2.3mdownpipes with outlet shoes and include 2 hoppers)	3 Spec 5

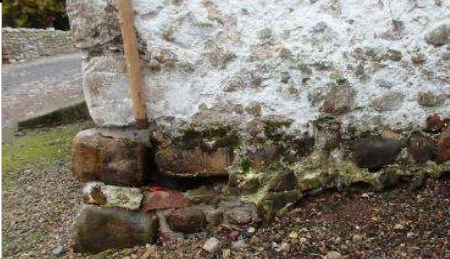
2.2.3	North end of east roof	The existing downcomer is corroded and discharges directly into the foundation stones.

Remove the downpipe, as the rainwater can be directed to the southern outlet.	1

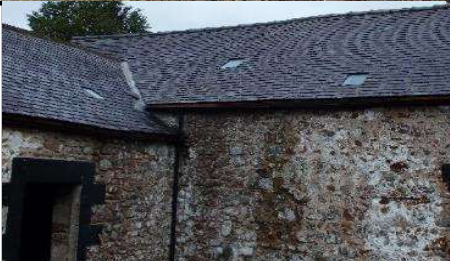
2.2.4	West roof	The plastic guttering and timber fascia has come loose.

Remove the timber fascia and remove the plastic guttering and renew with deep flow cast iron guttering. (Allow 10.5m of guttering, with 2no stop ends and 1no. outlet)	1 Spec 5

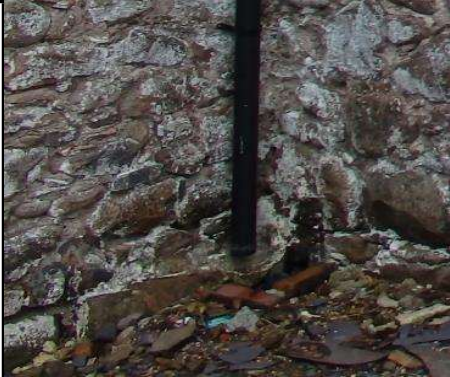
2.2.6		The existing downpipe discharges directly to the ground.

Install a new gully, linked to a drainage run to connect to the existing blocked system. (Allow for the installation of a 200mm sq, gully with cast iron grill. Assume the installation of 20m of underground drainage with 1no polypropylene inspection chamber)	1 Spec 6

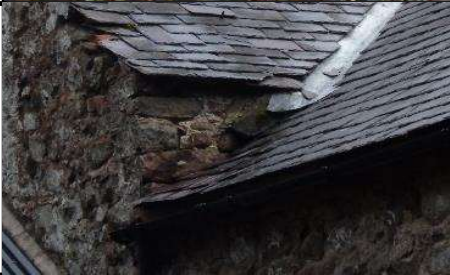
2.2.7	West roof north end	There is no guttering to this small section of roof.

Install a new cast gutter to discharge into the rear range gutter. (Allow 1.2m of guttering, with 1no stop end, 1no outlet and a 90 deg. Corner, with short section of downpipe.)	1 Spec 5

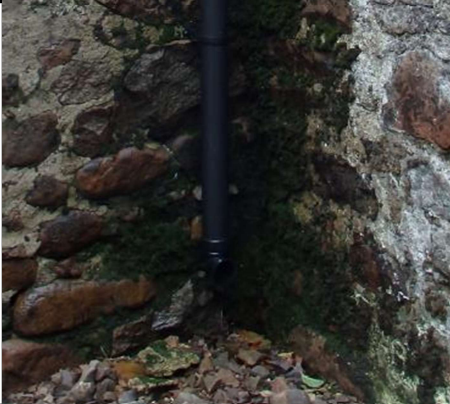
2.3.2	West roof	The plastic guttering is generally sound but the downpipe drains to the ground.

<p>Install a new gully with underground drainage to a soakaway.</p> <p>(Include for an outlet shoe. Allow for the installation of a 200mm sq, gully with cast iron grill. Assume the installation of 14m of underground drainage with a 1m sq. stone filled soakaway)</p>	1	Spec 6

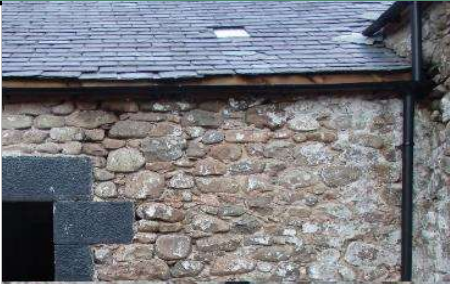
2.4.0		Rear Range				
2.4.1	South Roof	There is plastic guttering on timber fascias. The downpipe discharges to the ground.

<p>Remove the fascia. Install a new deep flow cast gutter and new downpipe.</p> <p>(Allow 16m of guttering, with 2no stop end, 1no outlet and a 90 deg. Corner. Include for a new section of 2.6m downpipe with an outlet shoe.)</p>	3	Spec 5

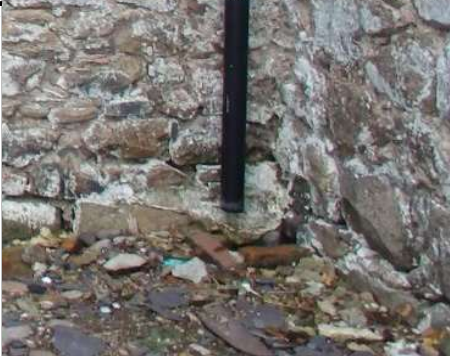
2.4.2	South Roof	The downpipe discharges directly on to the ground.

<p>Install a new downpipe with new gully with underground drainage to a soakaway.</p> <p>(Allow for the installation of a 200mm sq, gully with cast iron grill. Assume the installation of 8m of underground drainage with 1m sq, stone filled soakaway)</p>	3	Spec 5

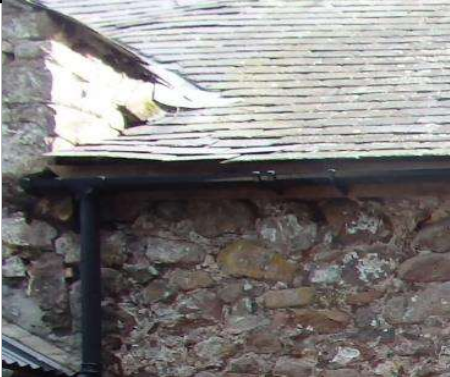
2.4.3	North roof	There is plastic guttering on timber fascias. The downpipe discharges to the ground.

<p>Remove the fascia. Install a new deep flow cast gutter and short section of downpipe.</p> <p>(Allow 16m of guttering, with 2no stop end, 1no outlet and a short section of downcomer to discharge to the gutter at the west of the store.)</p>	3	Spec 5
2.6.0		Pig sty				
2.6.1	South roof	The gutter is missing.

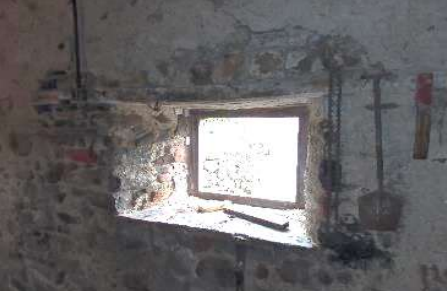
Rake out the loose mortar and patch repoint. (Assume a rate of 80% over an area of 7.5m sq.)	1 Spec 7	
3.1.9	Internal walls	There is plaster render internally which is loose and friable in places.		Brush off loose material and clear the debris.	3	
3.1.10	South internal wall	There is deflection to the timber lintels with displacement of the stonework above.

Renew the timber lintels and rebuild the masonry above. (Allow for 2no.oak lintels 100x200 laid flat 2.1m long and allow 1m sq of rebuild above.)	1 Spec 9 & 13	
3.1.11	North internal wall at east opening	There is loose masonry at the beam end.

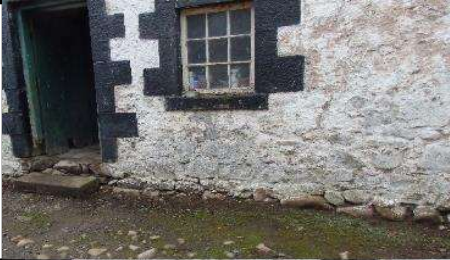
Repoint the crack and monitor. (1500mm long)	2 Spec 7	
3.2.2		There are open joints along the foundation stones to the south.

Deep tamp and repoint the stones. (1.5msq.)	2 Spec 11	
3.2.3		There are open joints along the foundation stones to the north.

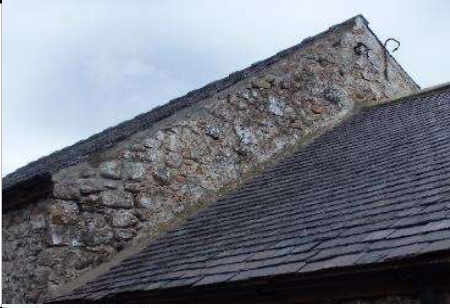
Install a new stone step. (Dressed stone step to match the existing stonework 150x200mm and 1250mm long)	3	
3.2.6	South Wall	There are a number of open joints.

Rake out the loose mortar and patch repoint. (Assume a rate of 80% over an area of 5m sq.)	2 Spec 7	
3.2.7	West Wall	There are loose, cracked, friable and missing mortar to the stonework joints across the whole wall.

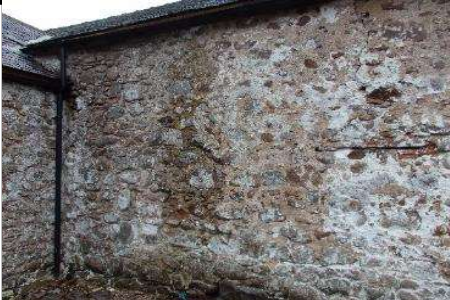
Rack out the mortar and repoint. (5m sq.)	1 Spec 7	
3.2.8		see above

Rake out the loose mortar and patch repoint. (Assume a rate of 75% over an area of 30m sq.)	2 Spec 7

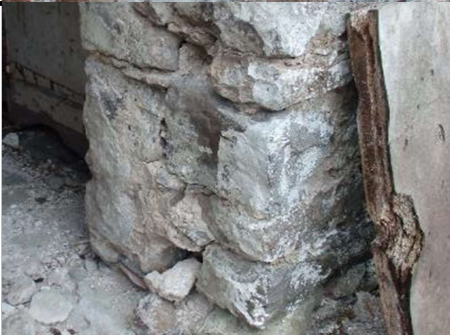
Hack out the timber and piece in with stonework, and repoint the crack. (1200x100mm area.)	1 Spec 8	
3.2.10		There is loose stonework in the door jambs.

Rebuild the section of loose masonry (Allow 2 x 0.3m sq.)	1 Spec 13	
3.2.11		The stone step has crumbled and represents a trip hazard.

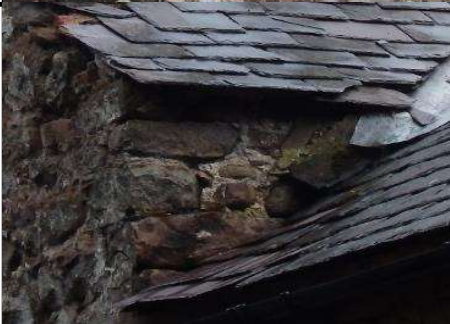
Install a new stone step. (Dressed stone step to match the existing stonework 150x200mm and 1050mm long)	1 Spec 2	
3.2.12	West Wall - north end	There are washed out joints and missing facework at the roof.

Rebuild and repoint the walling above the rear range roof. (Allow for 1m sq of rebuilding and 2msq.of repointing.)	1 Spec 7 & 13

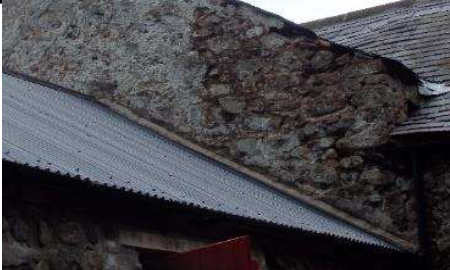
3.2.13	North Wall	There is missing pointing just above the store roof at the west.

Rake out the joints and repoint (1m sq.)	2 Spec 7	
3.2.14		There is loose mortar along the verge at the western roof face.

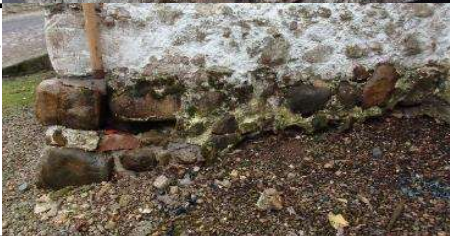
Repoint along the entire western verge. (0.3mx3.6m)	1 Spec 2	
3.2.15		There are open voids within the foundation stones at the base of the wall.

Deep tamp, piece in corework and repoint the stones. (2msq.)	2 Spec 8 & 11	
3.2.16		The limewash finish to the wall is flaking and loose.

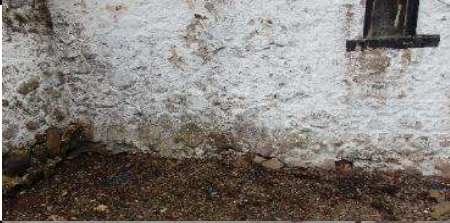
Include for pinning the walls from the outside to secure the cross wall. (Assume 8no 10mm stainless steel treaded bars drilled through the external stones into the cross wall and bedded in resin, install at 600mm vertical centres.)	2 Spec 10	
3.2.18				(Allow for an additional 25m sq. of repointing to be directed on site.)	Spec 7	
3.3.0	Store					
3.3.1	East wall	There are open joints and gaps to the foundation stones.

Deep tamp and repoint the stones. (1.5msq.)	2 Spec 11	
3.3.2		The timber lintel at the window is rotten.

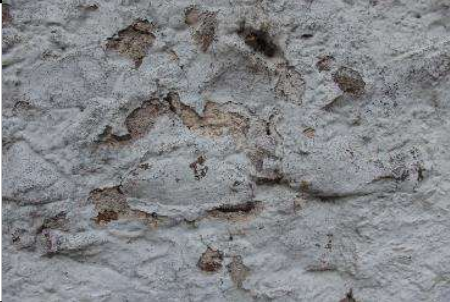
3.3.3		The limewash finish to the wall is flaking and loose.

Brush off the loose limewash and apply new coats of limewash to the walls and black paint the quoins as existing. (Apply 2 coats of a 'hot' mix limewash to an area of 17m sq)	3 Spec 12	
3.3.4	North wall	The limewash is loose and flaking.	see above	Brush off the loose material. (Allow a provisional quantity for patch repointing the entire elevation 17m sq at a rate of 75%)	2 Spec 7	
3.3.5		There are 3no. cracks

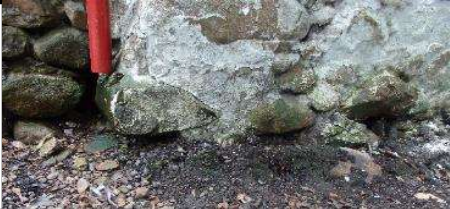
Rack out the cracks and repoint. (assume 3no.1500mm long)	2 Spec 7	
3.3.6		The foundation stone at the east corner is being undermined.

Include for packing in stonework into the gaps to secure the foundation stones.	1 Spec 8

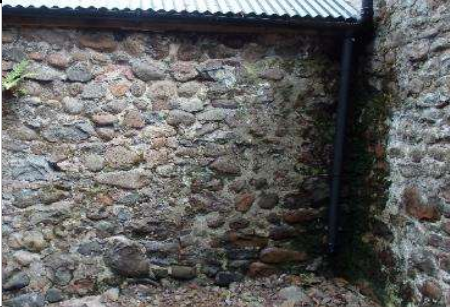
3.3.7	West wall	There is cracked and loose mortar joints to the south end and a build up of vegetation.

Clear off the vegetation, rake out the joints and patch repoint (Assume a rate of 75% over an area of 6.0m sq.)	2 Spec 2	
3.3.8		The end of the pattrass plate is corroded.

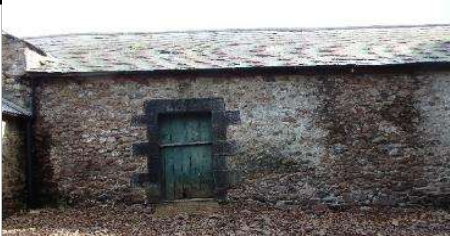
Rub down apply a rust inhibitor and redecorate.	3 Spec 15	
3.3.9				(Allow for an additional 5m sq. of repointing to be directed on site.)	Spec 7	
3.4.0	Rear Range					
3.4.1	North wall	There are areas of loose, cracked, friable and missing mortar to the stonework joints across the whole wall.

Rack out the mortar and repoint. (20m sq.)	2 Spec 7

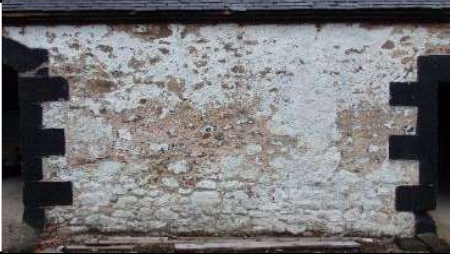
Carry out a resin repair the cracked stone.	3 Spec 14	
3.4.7		The limewash finish to the wall between the doorways is flaking and loose.

Brush off the loose limewash and apply new coats of limewash to the walls and black paint the quoins as existing. (Apply 2 coats of a 'hot' mix limewash to an area of 20.0m sq)	3 Spec 12	
3.4.8		There are poor and washed out mortar joints to the east of the arched opening.	see above	Rake and repoint (13.0m sq.).	2 Spec 7	
3.4.9		The end of the lintel to the southern door is rotten.

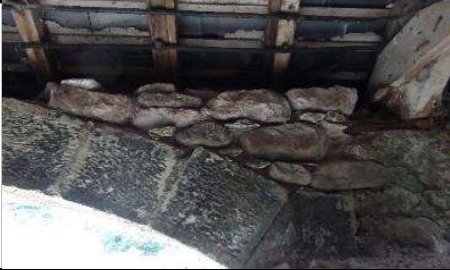
3.4.10	Internal South wall	The stones to the wall head to the west of the arched opening are loose.

Rebed the upper course of loose stones. (1.5m length)	3 Spec 13

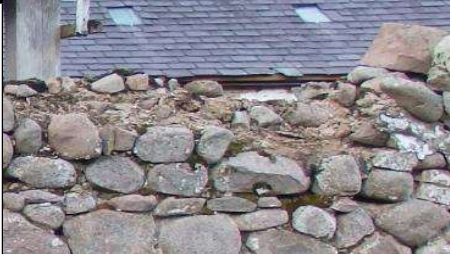
3.4.11				(Allow for an additional 35m sq. of repointing to be directed on site.)	Spec 7	
3.5.0	Lean to shelter					
3.5.1	South Wall	The wall head has collapsed with displaced stonework.

Take down the loose stonework and rebuild , including a hard capping. (Allow for rebuilding the top 500mm of wall, over a length of 6.5m)	1 Spec 13

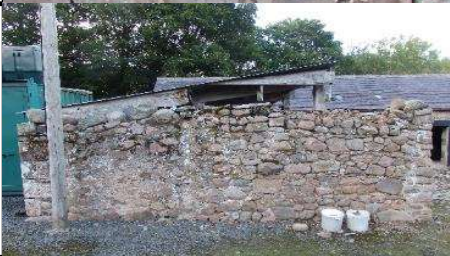
3.5.2		There are loose, cracked, friable and missing mortar to the stonework joints across the whole wall.

Deep tamp and patch repoint the wall. (Assume a rate of 80% over an area of 10m sq.)	2 Spec 7 & 11

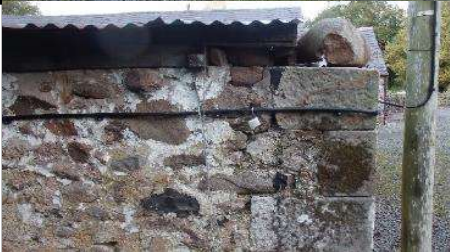
3.5.3	West wall at the south end	There is a small area of loose, cracked, friable and missing mortar to the stonework joints.

Rake out the mortar and repoint (1m sq.)	2 Spec 7

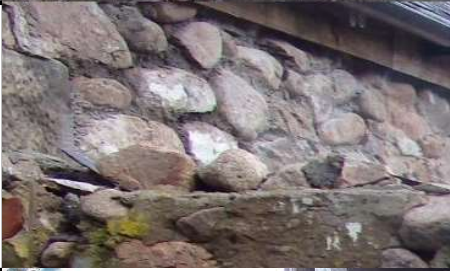
Rake out the mortar and repoint (1m sq.)	2 Spec 7	
3.5.5		There is loose masonry to the wall head.

Rebed the upper stones on the wall and form a hard capping to the wall head. (Assume a length of 1.8m)	2 Spec 13	
3.5.6	Internal face of the Southern wall	There are loose, cracked, friable and missing mortar to the stonework joints to the east of the wall

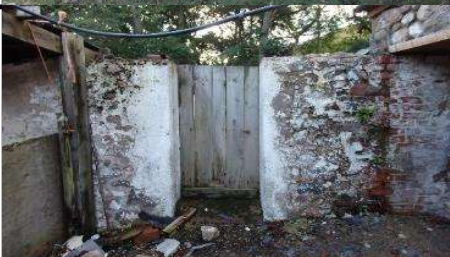
Deep tamp and patch repoint the wall. (6m sq.)	2 Spec 7 & 11	
3.5.7		The limewash finish to the wall between flaking and loose.

Brush off the loose limewash and apply new coats of limewash to the walls and black paint the quoins as existing. (Apply 2 coats of a 'hot' mix limewash to an area of 30.0m sq)	3 Spec 12

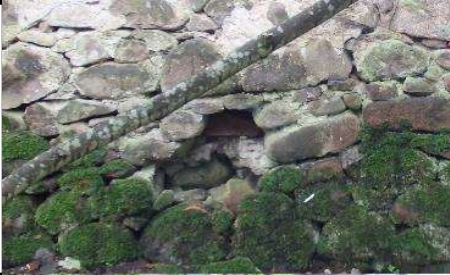
3.6.0		Pig Sty and Bridge Buttresses				
3.6.2	North wall	There is a hole at low level.

Piece in new stonework (0.5m sq.)	1 Spec 8	
3.6.3		At low level there are loose, cracked, friable and missing mortar to the stonework joints.

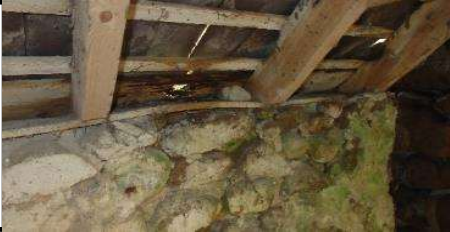
Rake out the mortar and deep tamp and repoint (2m sq.)	2 Spec 7 & 11	
3.6.4		There are loose stones to the eaves

Rebed the wall head at the eaves. (Allow a 200x38 lintel/wallplate)	1 Spec 13	
3.6.5		There is a large tree adjacent to the north wall, which if it fell would damage the wall.		Consider removal of the tree	2 Spec 16

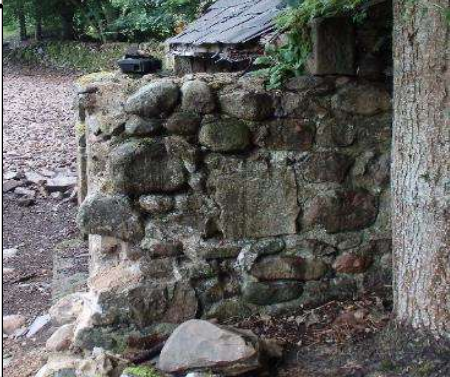
Piece in with new stonework. (1200x300mm)	1	
3.6.7		There perimeter wall is missing a capping which has fallen.

Rebed the fallen capping. (1.5m long.)	1	
3.6.8		There is a small area of loose, cracked, friable and missing mortar to the stonework joints.	see above	Rake out the mortar repoint (1.5m sq.)	1 Spec 7

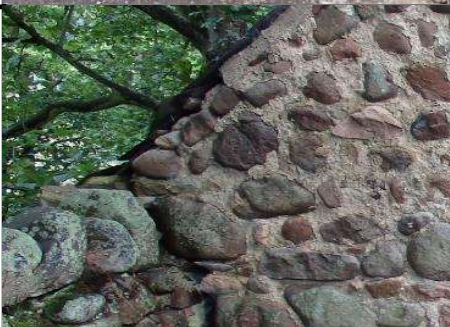
<p>Consider rebuilding the wall and include a gate post. (1200mm high and 750mm long, with a stone gate post at the end.)</p>	<p>2 Spec 13</p>	
<p>3.6.10</p>	<p>South wall</p>	<p>There are gaps below the capping and some open joints.</p>	 	<p>Rake out loose and open joints and repoint the gaps</p>	<p>2 Spec 7</p>	
<p>3.6.11</p>	<p>West wall</p>	<p>There is a gap to the northern end of the wall.</p>

<p>Piece in new stonework (250x750mm.)</p>	<p>2 Spec 8</p>	
<p>3.6.12</p>		<p>The is loose stone along the verge to both roof faces</p>	 	<p>Rebed and rebuild the walls at verge level (Allow the top 300mm of wall head.)</p>	<p>1 Spec 13</p>

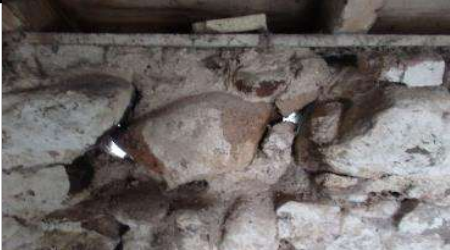
3.6.13	Internal walls	Some of the mortar has washed out of the internal walls

Rake out loose mortar and repoint. (Allow 4m sq.)	2 Spec 7	
3.6.14	Bridge Abutments	The mortar joints are washed out with large voids and loose masonry.

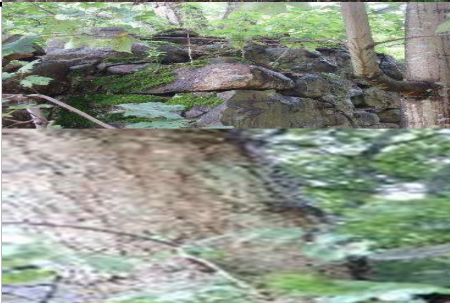
Fully deep tamp and repoint. (Allow 25m sq.)	1 Spec 7 & 11	
3.6.15		There are loose stones to the wall heads of the buttresses

Rebuild the top and form a hard mortar capping with rough raking to direct water from the wall head. (Allow rebuilding the top 750mm.)	1 Spec 13	
3.6.16		There are 2no. Trees surrounding the buttresses which have the potential to cause damage to the buttress

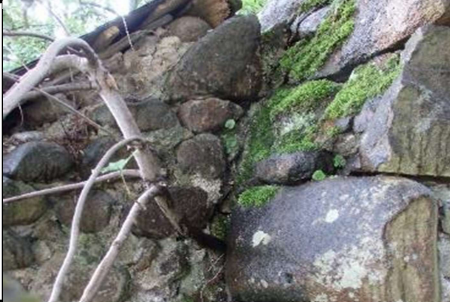
3.6.17		There is a sapling growing in the west buttress.

Remove the tree and dig out the roots and make good the stonework.	1 Spec 16	
3.6.18				(Allow for an additional 5m sq. of repointing to be directed on site.)	Spec 7	
					sub total

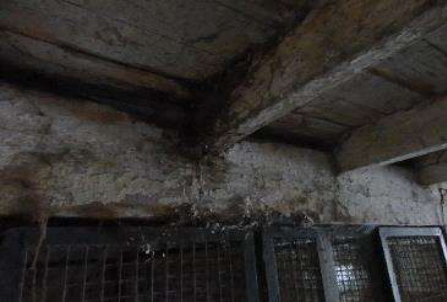
Inspect the beams for rot, and allow a timber treatment.	1 Spec 3	
4.2.4		One of the timber floor beams is rotten.

Cut out the rotten beam and allow for a complete replacement with new timber (165x65mm beam)	1 Spec 2	
4.3.0	Store					
4.3.1	Floor	The floor is a concrete floor in reasonable condition.		No works required.		
4.4.0	Rear Range					
4.4.1	Floor	The floor is a concrete floor in reasonable condition.		No works required.		
4.5.0	Lean to shed					
4.5.1	Floor	The floor is a stone flags and earth.

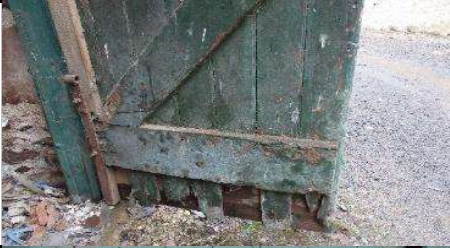
5.0.0		WINDOWS/DOORS/JOINERY				
5.1.0		Cart Shed				
5.1.1	East Door	The base of the boards to both door leafs is rotten.

Cut off the rotten timber and splice in new timber boards. (Allow for 14no. 140x28mm boards.)	2	Spec 18
5.1.2		The paintwork is flaking on both the door and the frame.

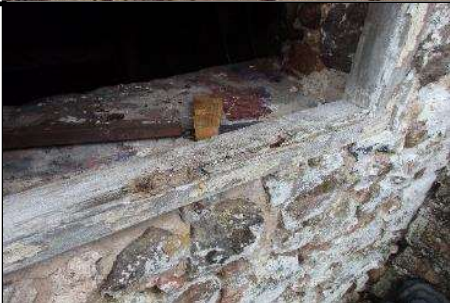
Rub down the timber to remove loose paint and redecorate internally and externally.	2	Spec 15
5.1.3	South window	The cill is rotten and decayed.

Cut out the cill and and renew with a new piece of timber (Allow 75x55mm accoya rebated cill.)	2	Spec 18

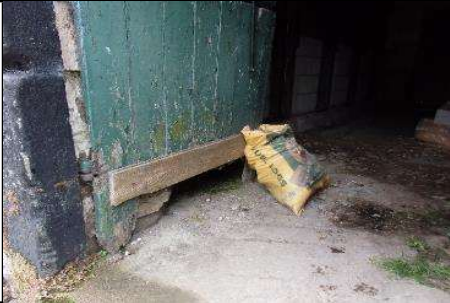
Remove the glass and install new glazing bars then reglaze securing the glass with linseed putty.	2 Spec 18	
5.1.5		The paintwork is flaking on the window.	see above	Rub down the timber to remove loose paint and redecorate internally and externally.	2 Spec 15	
5.2.0	Stable/Granary					
5.2.1	Granary door on east wall.	The boards to the bottom portion of the door are warped and rotten.

Renew the boards with new timber boards (Renew boards with accoya 160x28mm boards.)	3 Spec 18	
5.2.2		The paintwork is flaking on the door and frame.	see above	Rub down the timber to remove loose paint and redecorate internally and externally.	2 Spec 15

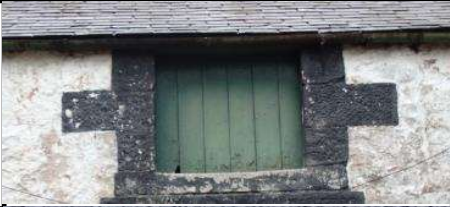
5.2.3	Granary upper door	The paintwork is flaking on the door and frame.

Rub down the timber to remove loose paint and redecorate internally and externally.	2 Spec 15	
5.2.4	Stable - northern window on the east elevation	The paintwork is flaking on the window and the putty is crumbling and missing.

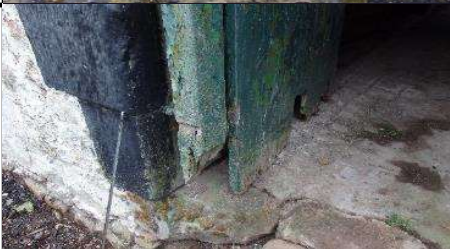
5.2.5	Stable door to the east wall	One leg of the frame is rotten and the frame is displaced as the hinges are corroded.

Ease the hinges. Cut out the rotten section of door frame and splice in a new section of timber. (Allow for a 80x100x400mm long splice.)	1 Spec 18

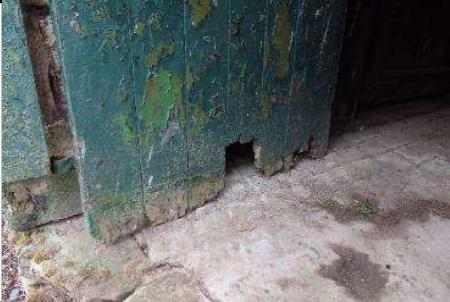
5.2.6		The base of the door is rotten

Cut out the rotten timbers, splice in new timbers and include for the installation of a now horizontal board to the base of the door. (Assume 4no. Panels are cut back and 3no are spliced in.)	1 Spec 18	
5.2.7		The paintwork is flaking on the door and frame.	see above	Rub down the timber to remove loose paint and redecorate internally and externally.	2 Spec 15	
5.2.8	Stable - southern window on the east elevation	The lower louvre is loose.

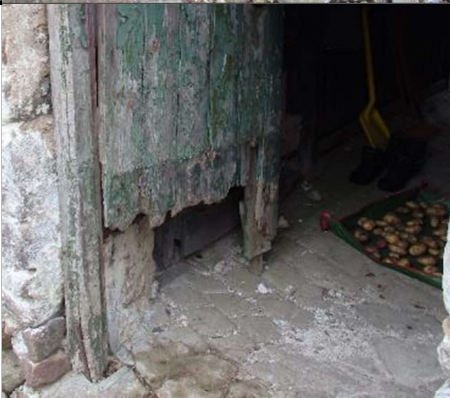
Cut out the rotten section of door frame and splice in a new section of timber. Include for a new frame leg. (Allow for a 80x100x400mm long splice, and a 80x100mm frame.)	1 Spec 18	
5.2.11		The door is rotten and decayed.

Salvage the ironmongery and install a new door. (Provide a new accoya timber ledged and braced batten door and include for decoration)	1 Spec 19 & 15	
5.3.0	Store					
5.3.1	East window	The paintwork is flaking on the door and frame.

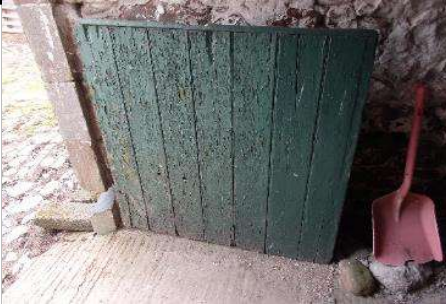
Install a new door and ironmongery (Provide a new accoya timber ledged and braced batten door and include for decoration)	3 Spec 19 & 15	
5.4.2		The boards to the lower section are rotten and the hinges are corroded.

Ease the hinges and splice in new timbers to the base of the door. (Splice in new section of timber 180x25mm.)	2 Spec 19	
5.4.3		The paintwork is flaking on the door and frame.	see above	Rub down the timber to remove loose paint and redecorate internally and externally.	2 Spec 15	
5.4.4	Doors to the south elevation at the arched opening	The doors are missing.

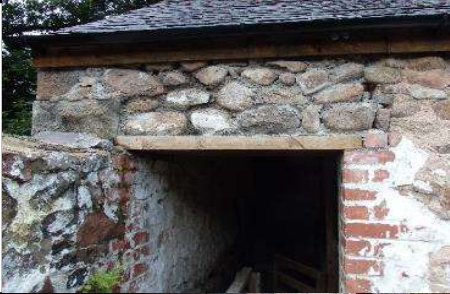
5.4.5	Door to the south elevation at the west	The door is missing

Consider installing new door and frame. (Provide a new accoya timber ledged and braced batten door and frame include for decoration)	3 Spec 19 & 15	
5.4.6	Door to the north elevation.	The boards are loose and are rotten at the base.

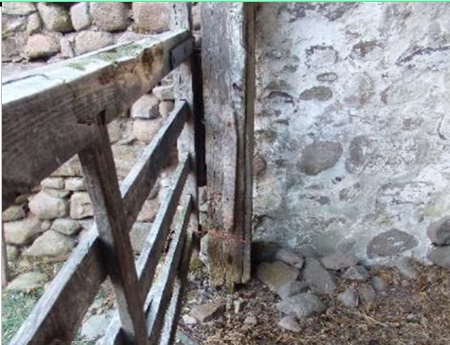
Refix the boards and splice in new timber boards (Splice in 2no. new sections of timber 180x25mm.)	3 Spec 19 & 15	
5.4.7		The paintwork is flaking on the door and frame.	see above	Rub down the timber to remove loose paint and redecorate internally and externally.	2 Spec 15	
5.5.0	Lean to shed					
5.5.1	Posts	There is rot to the bottom of 4no. post and rot at the top of 1no. post.

Fully inspect, and splice in new timbers. (Cut out the base of the rotten timbers out their socket bases. Include for splicing in 5no. 200x200x500mm accoya timber pieces)	3 Spec 18

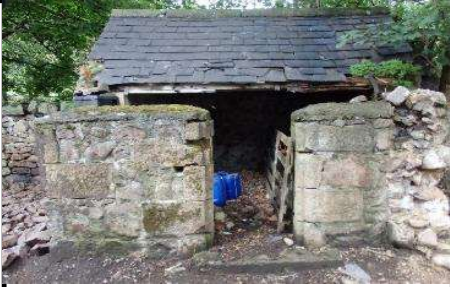
5.6.0		Pig Sty				
5.6.1	Perimeter wall	The existing gate is missing.

Consider installing a ledge and braced boarded half height door and frame to the existing opening to secure the pig sty. (Provide a new accoya timber ledged and braced batten door and frame include for decoration)	3 Spec 19 & 15	
5.6.2		The existing gate between the pigsty and store is missing.
