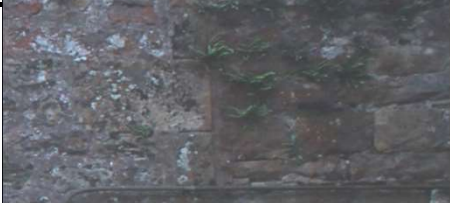
3.1.4		The wall above the gateway has vegetation growth and the mortar joints are cracked and in poor condition.

Remove the vegetation, rake out and repoint.  (1.5m sq.)	2  Spec 6

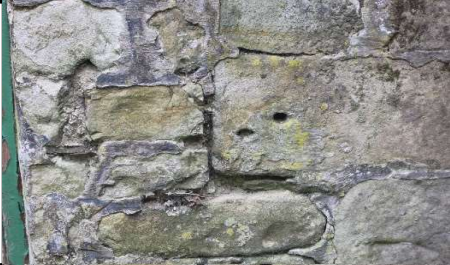
Rake out and repoint the wall  (36m sq.)	2  Spec 6	
3.1.6		There is an area of washed out and friable joints to the west of the Granary door.

Rake out and repoint the wall  (1m sq.)	1  Spec 6	
3.1.7		There is an area of washed out joints to the west of the Granary door at low level

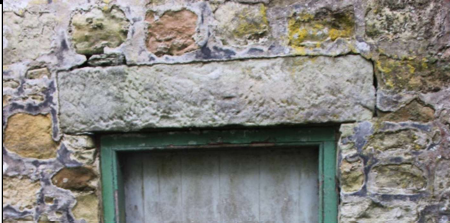
Deep tamp the wall  (1m sq.)	2  Spec 7	
3.1.8		There are gaps around the lintel above the Granary door.

Point up the gaps around the lintel	2  Spec 6

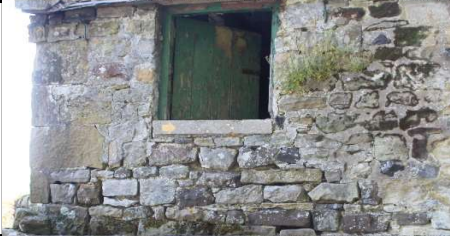
Clear out the debris repoint and fill in the collapsed hole.  (Rebuild and piece in at the collapsed section 1m sq. Repoint 18m sq.)	3  Spec 10 & 6	
3.1.14	East Wall	The is an area of washed out and missing mortar joints at the southern end of the wall.

Rake out and repoint  (5m sq.)	1  Spec 6	
3.1.15		The wall appears to have been repointed in the past with a cement based mortar, which is having a detrimental impact on the stone which is eroding more quickly than the stone leaving water traps on the wall. There are areas of loose and cracked mortar.

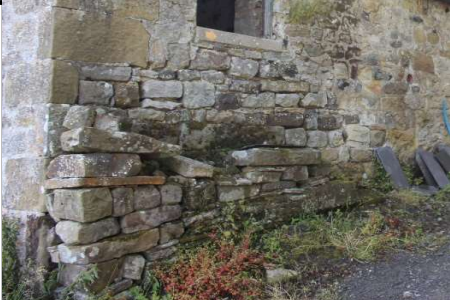
Rake out and repoint the wall  (20m sq.)	2  Spec 6	
3.1.16		There is a small section of loose stones piled at the southern end of the wall.

Remove the stones.	3

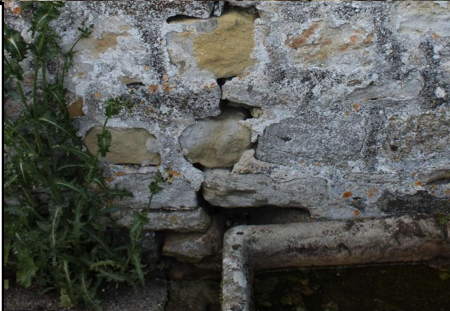
Undertake pinning and repoint the crack. (Skew drill the head and insert 2no 10mm stainless steel rods bedded in resin.)	1 Spec 9	
3.1.21		There are washed out joints to the wall above the gulley

Deep tamp and piece in with stone. (1m sq. deep tamping.)	1 Spec 7	
3.1.22		There is a crack to the west of the Granary window.

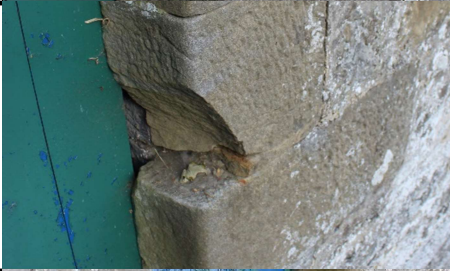
Rebed the stone.  (1.5msq.)	2  Spec 5	
3.1.28		A section of one of the quoins to the first floor door at the southern jamb has broken away, the cracked piece is on site.

Carry out a resin repair the broken stone.	2	
3.1.29		There are open joints below the first floor doorway

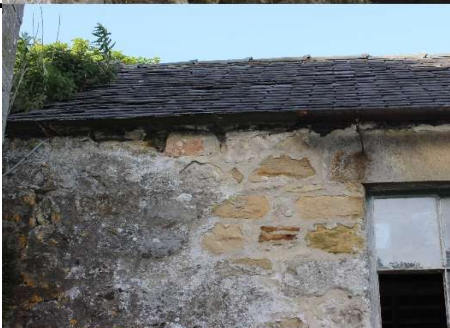
Repoint under the cill.  (0.5m sq.)	1  Spec 6	
3.1.30		There is vegetation growth and poor mortar joints to the northern end of the building.

Rake out and repoint the wall  (6.5m sq.)	1  Spec 6

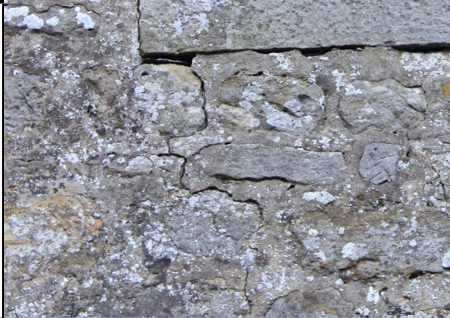
3.1.31		The wall appears to have been repointed in the past with a cement based mortar, which is having a detrimental impact on the stone, which is eroding more quickly than the stone leaving water traps on the wall. There are areas of loose and cracked mortar.

Rake out and repoint the wall  (33m sq.)	2  Spec 6	
3.1.32		The wall above the gateway has vegetation growth and the mortar joints are cracked and in poor condition.

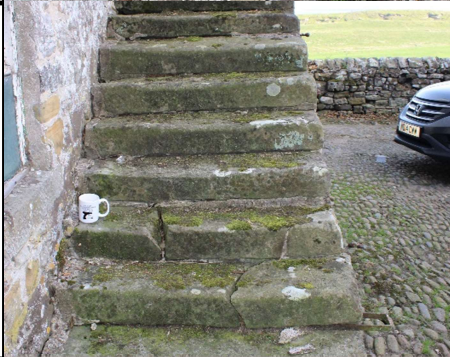
Remove the vegetation, rake out and repoint.  (1.5m sq.)	2  Spec 6	
3.1.33		The stones to the steps are in poor condition with open joints and some are displaced.

Rebed the stone steps and repoint.	2  Spec 6 & 5	
3.1.34		The wall below the steps has vegetation growth and the mortar joints are cracked and in poor condition.

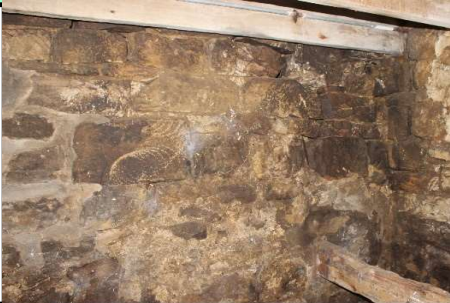
3.2.0		Internal Walls				
3.2.1	North Wall Ground Floor Granary	There are some open joints to the north east corner.

Remove the vegetation, rake out and repoint.  (2.0m sq.)	2  Spec 7	
3.2.2	West Wall Ground Floor Granary	The is a crack and rot to the timber lintel over the blocked opening.

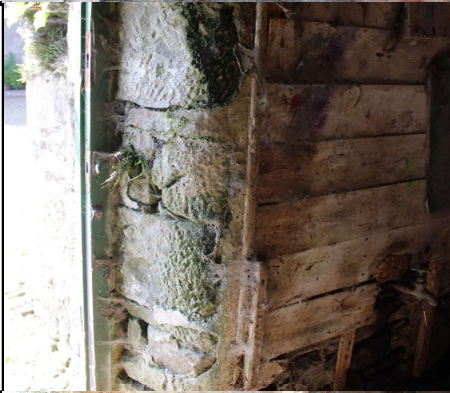
Allow for renewal  (Allow 2no. new Accoya timber lintels 100x125mm 1220mm long)	1  Spec 11	
3.2.3		There are some open joints to the northern jamb of the doorway

Allow for repointing  (1.0m sq.)	3  Spec 6	
3.2.4		There are open joints to the wall between the door and the window

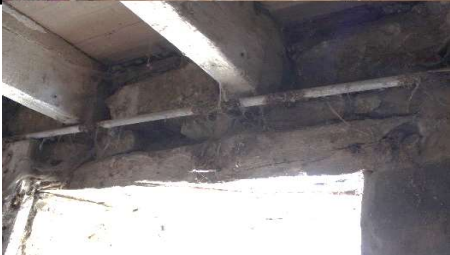
Piece in stone and repoint.  (Assume piecing and repointing around the northern most 10 joist ends.)	2  Spec 10	
3.2.6		There is evidence of rot to the window lintel.

Inspect and insert boron rods to prevent further rot.	2	
3.2.7				Allow a provisional sum for the replacement of the lintel above.		<b>£300.00</b>
3.2.8	North Wall First Floor Granary	At the northern end there are open joints with washed out mortar. There are washed out joints from a leak.

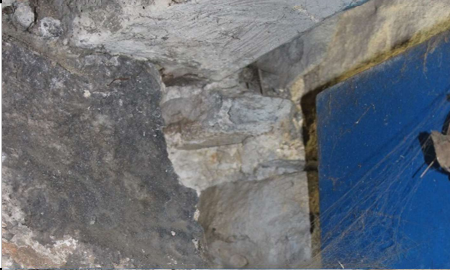
3.2.14		The inner lintel to the door is rotten and there is loose stone above.

Install a new timber lintel and make good the loose stonework.  (Allow 1no. new Accoya timber lintels 100x100mm 1400mm long)	2  Spec 11	
3.2.15		There is a small area of open joints at the southern jamb of the doorway.

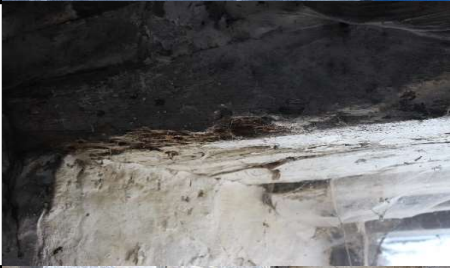
Repoint  (0.5m sq)	3  Spec 6	
3.2.16		There is rot to the lintel to the northern window.

Install a new timber lintel.  (Allow 1no. new Accoya timber lintels 100x100mm 1200mm long)	1  Spec 11	
3.2.17		There is loose stone to the cill of the northern window.

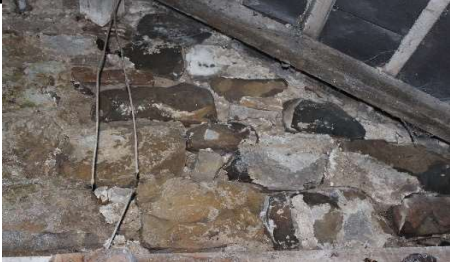
3.2.18	Store North wall	There is poor point and loose mortar joints at the roof/eaves.

Rake out the loose mortar and repoint (1.0m sq.)	2  Spec 6	
3.2.19		There are loose mortar joints at the top of the wall to the west..	 	Rake out the loose mortar and repoint (1.0m sq.)	2  Spec 6	
3.2.20		There is loose stonework above the door.	 	Repoint (1.0m sq.)	2  Spec 6	
3.2.21		There is loose render to the door jamb.	 	Brush off the loose material	3

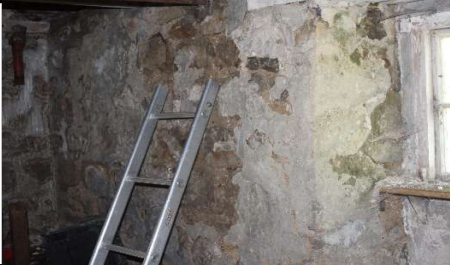
3.2.22	Store East Wall	To the north of the window there is loose render.

Hack off the loose material.	2	
3.2.23		There is rot the lintel to the southern window.

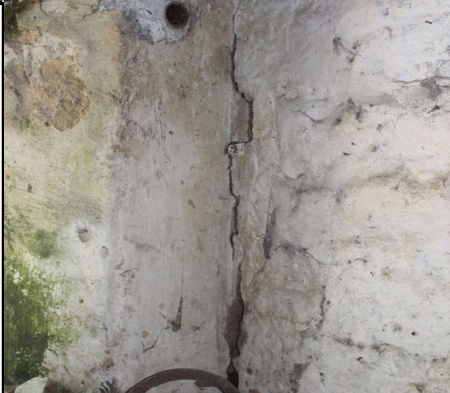
Install a new timber lintel.  (Allow 1no. new Accoya timber lintels 100x100mm 1200mm long)	1  Spec 11	
3.2.24		There is a crack at the junction with the southern cross wall

Include for stitching in rods from the external face to secure the eastern wall to the southern cross wall. Repoint the crack  (Allow installing 5no. 10mm helibar 1200mm long. )	1  Spec 9	
3.2.25	Store West Wall	There is some loose plaster to the northern section of the wall.

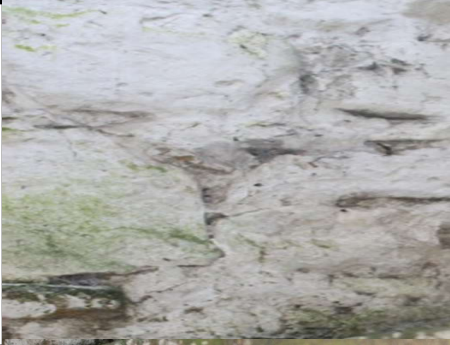
Rebed the stonework	3  Spec 5	
3.2.27		There is a crack in the eastern wall

refer to item 3.2.24 above	—	—
3.2.28		There is a hole at the east end of the wall

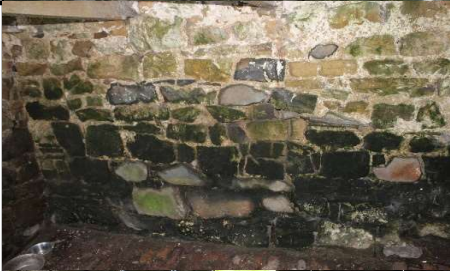
Piece in stonework  (approx 200mm x 500mm)	2  Spec 10	
3.2.29		There are open joints at low level to a section of wall, which is retaining.

Repoint.  (4m sq.)	3  Spec 6

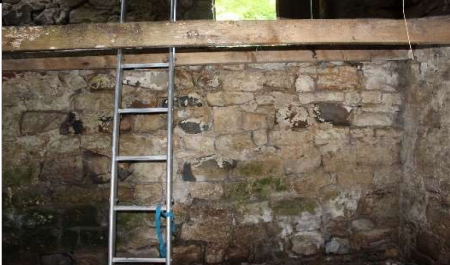
3.2.30	Kennel - East Wall	The wall has many open and poor mortar joints.

Repoint the entire wall  (11m sq.)	1  Spec 6	
3.2.31	Kennel - South Wall	To the east end there are open and washed out joints.

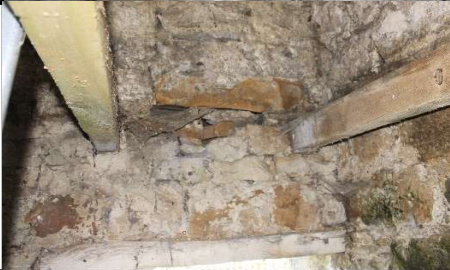
Rake out and repoint  (2m sq. )	1  Spec 6	
3.2.32		There are loose stones around the floor joist ends..

Rebed and repoint around the floor joist ends	2  Spec 6	
3.2.33		There is a loose stone at the cill of the higher window opening..

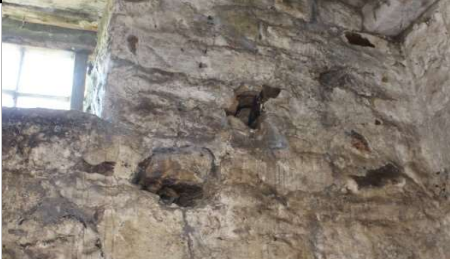
3.2.34		There are a number of holes below the higher window.

Piece in stonework	3  Spec 10	
3.2.35		There is loose stone to the apex

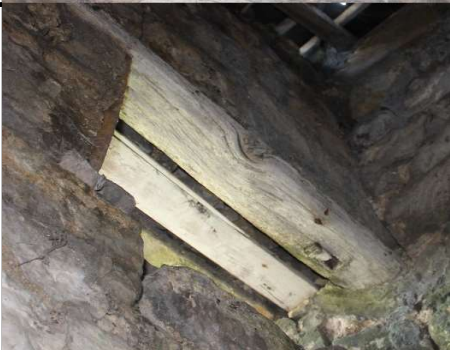
Rebed and repoint.  (1m sq.)	2  Spec 6 & 5	
3.2.36		The lintel to the upper window appears undersized.

Check for deflection and condition.  (For tender purposes assume renewal.)	1  Spec 11	
3.2.37	Kennel - West Wall	There appears to be displaced masonry at the bearing of the central rafter member..

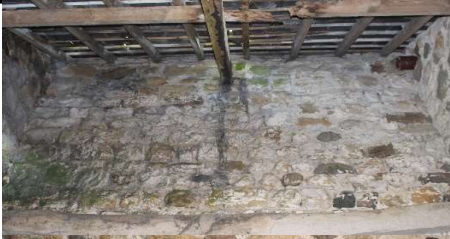
3.2.38		There are open joints to the upper portion of the wall.

Repoint  (14m sq. )	2  Spec 6	
3.2.39		There are some open joints to the lower portion of the wall.

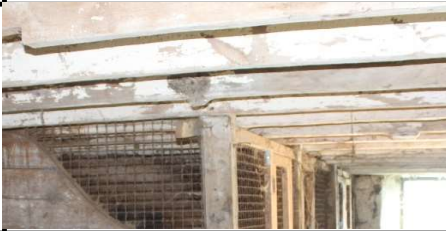
4.3				Allow a provisional sum for additional joist repairs once the top surface can be inspected when the floor boards have been removed.		£750.00
4.4		There is evidence of minor woodworm to joists

Inspect all the timbers, and apply an insecticide treatment to all retained timbers.	1  Spec 3

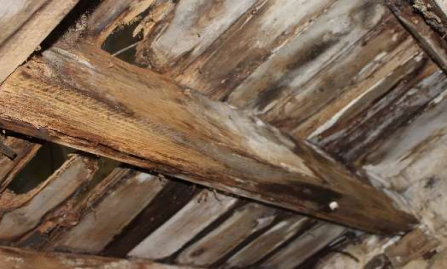
4.6				Consider applying a wood wax transparent sealer. (Allow for 45m sq boards)	3 Spec 12	
4.7	Store.	The floor is concrete and in reasonable condition.		No works required.	—	—
4.8	Floor	There is rot to the boards to the partial upper floor deck.

Strip out the rotten boards.  Consider replacement of the boards if this is required for storage purposes (Allow for 3m sq of 150x25mm T & G boards)	2  3 Spec 12	
4.9	Kennel	The floor is lined with bricks. A number of which have decayed.

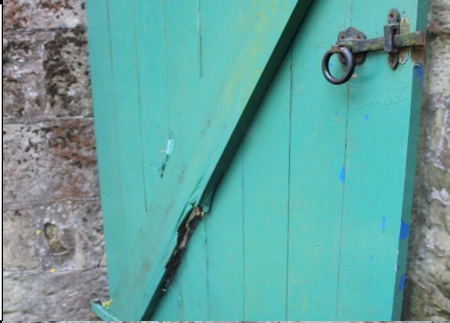
5.1	Gate at the north west corner.	The brace is rotten and the central two panels are rotten, and the paint is flaking.

Take apart the door and insert new panels and new brace.  (Include for a new brace assume 200x38mm and 2no. 150x25 T & G boards include for decoration)	2  Spec 14 & 17

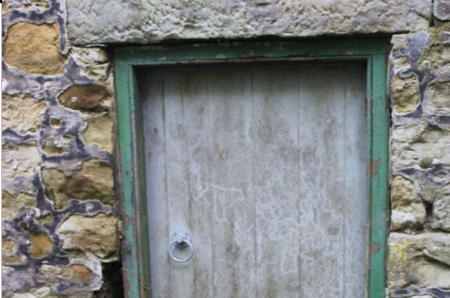
5.2	North Granary Door	The base of the door frame is rotten.

Cut out the rotten timber frame and splice in new sections and redecorate.  (Renew the base of the frames with Accoya timber 80x65mm sections 250mm long)	3  Spec 14

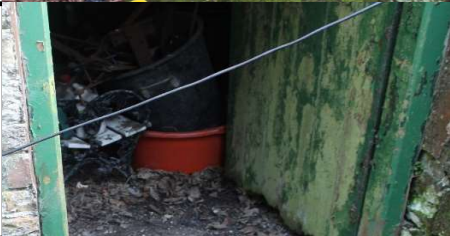
Rub down the timber to remove loose paint and redecorate internally and externally.	2  Spec 17	
5.4	North Store Door	There is decay to the base of the door boards.

Treat the timber and install a horizontal board with chamfered top. (Include a 150x25mm Accoya board the width of the door with chamfered upper edge.)	3  Spec 14	
5.5		The base of the door frame is rotten.

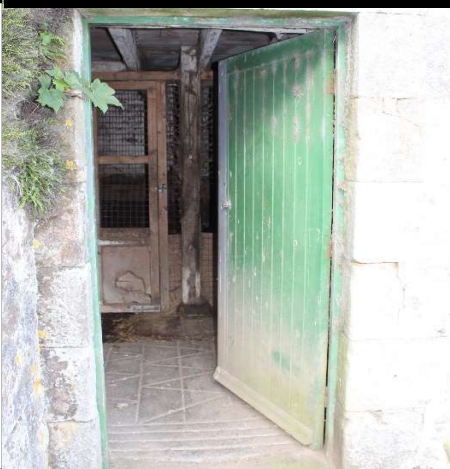
<p>5.18</p>	<p>Granary Ground floor Door</p>	<p>The paintwork is flaking on the door and frame.</p>

<p>Rub down the timber to remove loose paint and redecorate internally and externally.</p>	<p>2</p> <p>Spec 17</p>	
<p>5.19</p>	<p>Granary Ground Floor west Window</p>	<p>There is peeling paint, missing putty, missing glass pane and the timber is rotten.</p>

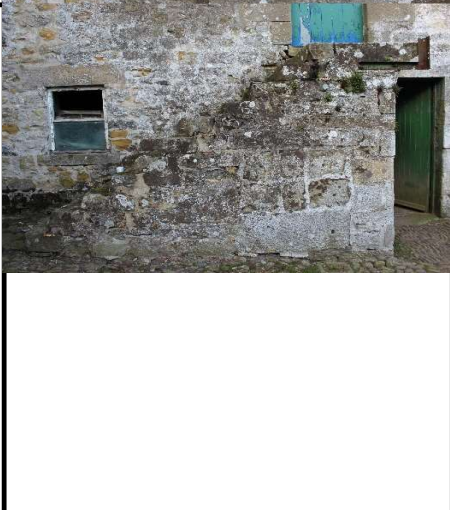
<p>Renew with a simple opening casement window with 4 panes.</p> <p>(Approx. 800mm wide and 910mm tall.)</p>	<p>1</p> <p>Spec 15</p>	
<p>5.20</p>	<p>External Steps</p>	<p>The handrail is missing completely.</p>

<p>Include for a new timber handrail.</p> <p>(Fabricate the handrail and posts in Accoya timber, allow for 5no 100mm sq posts, a 100x38mm rounded top rail 4.7m long and a 100mmx38mm mid rail 4.5m long. Allow for rebedding the existing metal bands to secure the posts, and allow for 2no. M14 stainless steel resin bolts into the stone joints to secure the posts.)</p>	<p>3</p>

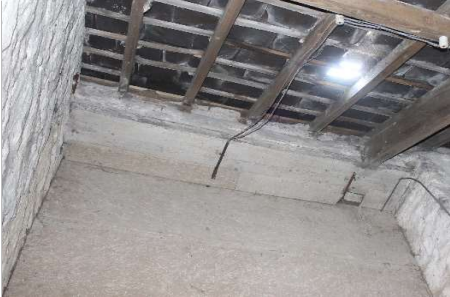
5.21	First floor opening into Granary and Store.	The opening is currently blocked with an sheet which appears to be asbestos.

<p>The removal is included in General item 6. Include for forming a timber partition to block the opening</p> <p>(Assume framing the opening 2260mm wide and 1830mm high with 100x50mm timber studs at 600mm centres with a sole plate, head and half height noggins. Clad the studs with 22x150mm T &amp; G horizontal boards to the Granary side)</p>	1	
					sub total
